Triple Redundancy Failure on the Space Station

November 2007

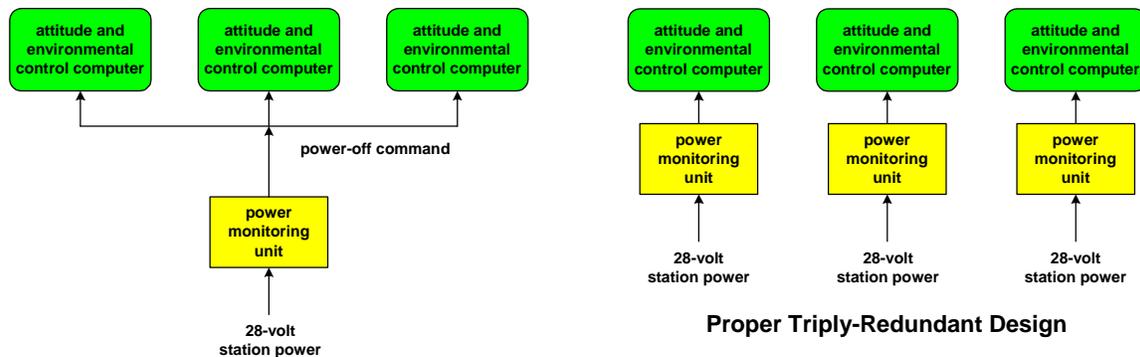
Once the problem was understood, it became clear that the system suffered from a fatal design flaw. The supposedly triply-redundant design included a single point of failure – the external power monitoring unit that, by itself, could turn off all of the computers. Should it fail (as it did due to condensation), the triply-redundant system was down.

A proper triply-redundant system design would make sure that no single failure (or even a dual failure) could take down the system. In this case, this condition could have been satisfied by providing a separate power monitoring unit for each computer.

Single Point of Failure

Proper Triply-Redundant Design
